SPEEDWELL FORGE DAM

NDS No. PA-00345

PHASE I INSPECTION REPORT NATIONAL DAM INSPECTION PROGRAM

Name of Dam: SPEEDWELL FORGE DAM, NDS NO. PA-00345
State & State No. PENNSYLVANIA, 36-257
County: LANCASTER
Stream: HAMMER CREEK
Date of Inspection: October 30, 1978

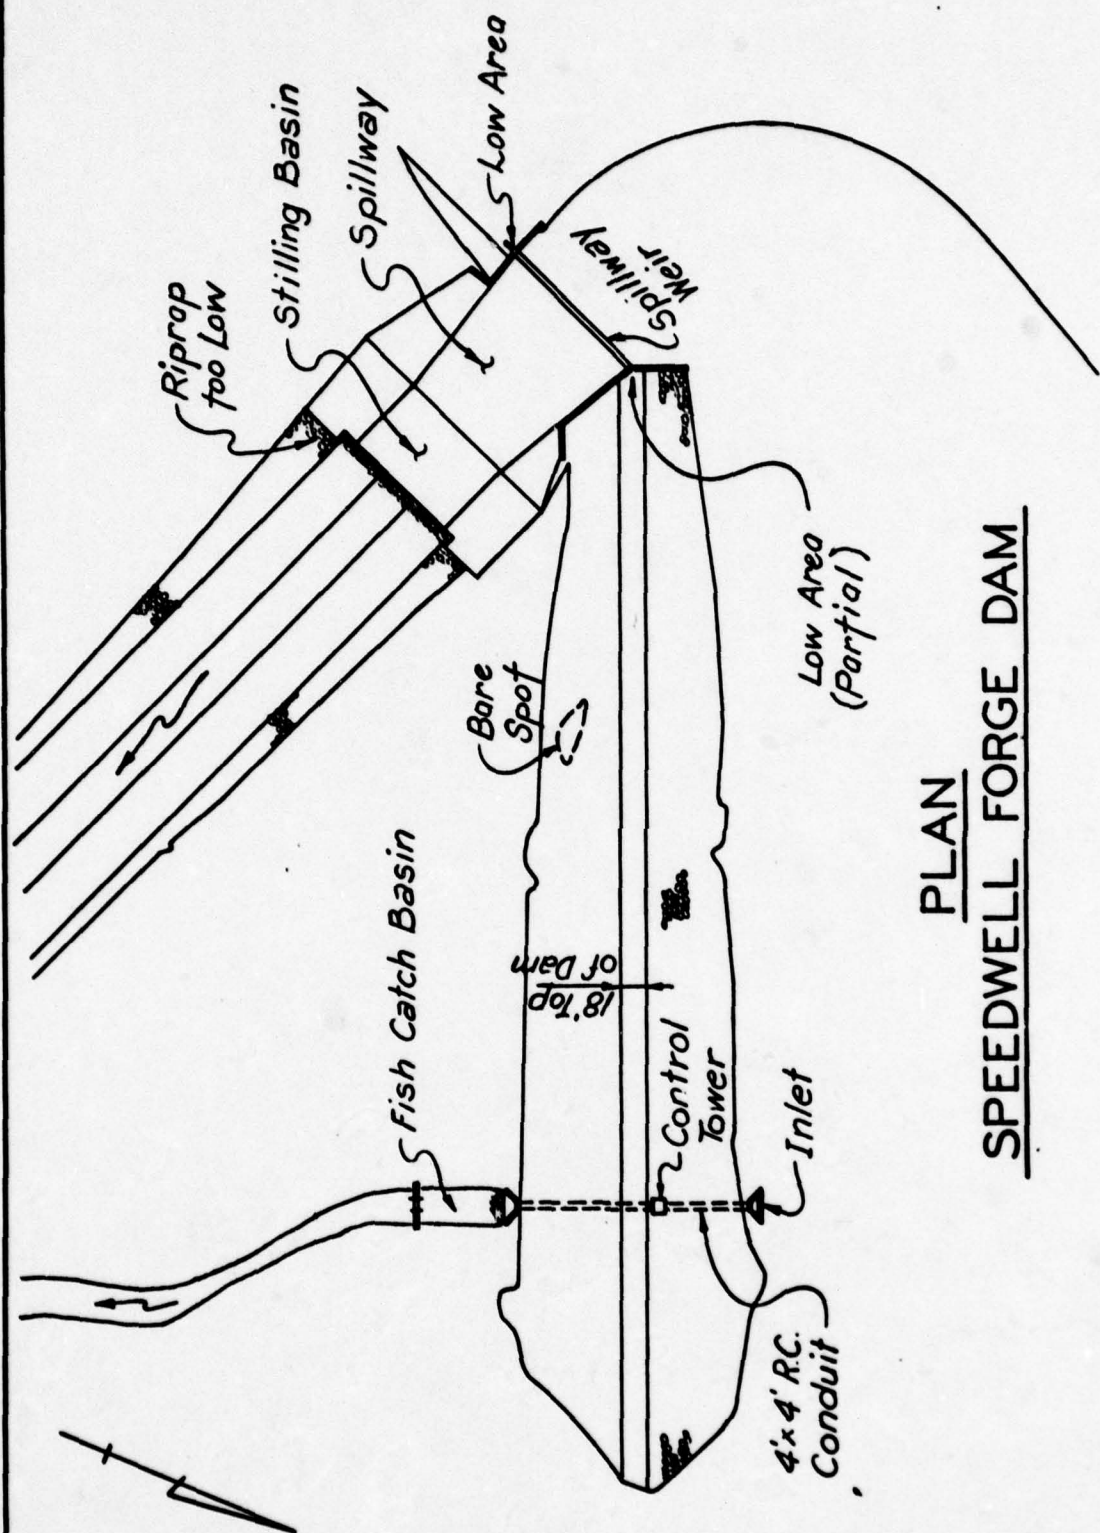
SPEEDWELL FORGE DAM
PA. 345
INSPECTION SURVEY

The results of the inspection survey show an uneven profile of the embankment crest. Refer to Plate A-II in Appendix A. While this condition does not affect the stability of the embankment, providing a uniform elevation at the design crest level would provide some improvement to the capacity of the facility.
